Manhole Inspection Summary

Manhole # S45I__017MH

Insp Date: **4/24/08 11:42 AM**

Location Address: **404 s castle st**

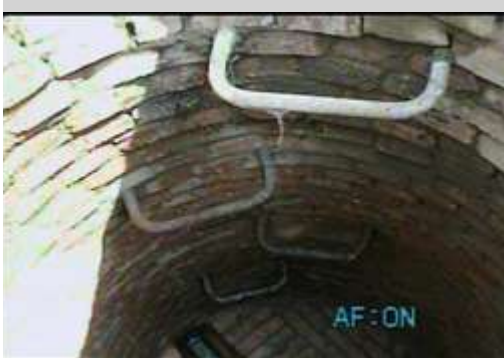
Defect 2

Count: **4** Missing: **0** ☒ **Corroded**

corroded stairs

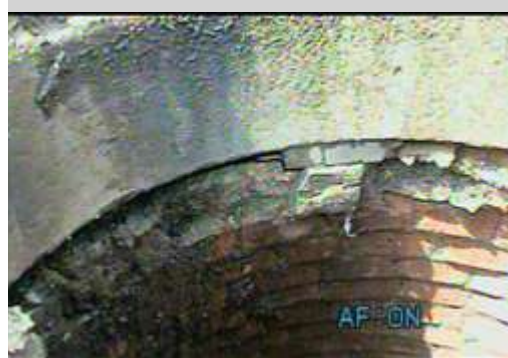
Defect 1

Condition: ☐ Sound ☒ **Cracked** ☐ Root Intrusion ☒ **Loose Brick** ☒ **Deteriorated**

Infiltration: ☐ None ☒ **Joint** ☐ Cracks ☐ Mortar ☐ Roots ☐ Wall

loose brick, crack and deteriorated frame
adjustment
with infiltration from joint

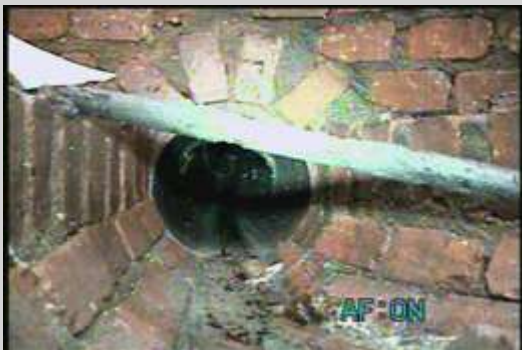
12 O'Clock Outflow

8 in. Circular Gravity Sewer
Pipe Out @ 12 O'Clock

Infiltration: **None** Pipe Seal Cond: **Unknown**

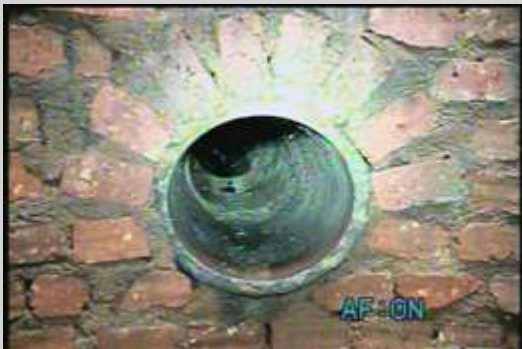
3 O'Clock Inflow

8 in. Circular Gravity Sewer
Pipe In @ 3 O'Clock

Infiltration: **None** Pipe Seal Cond: **Unknown**

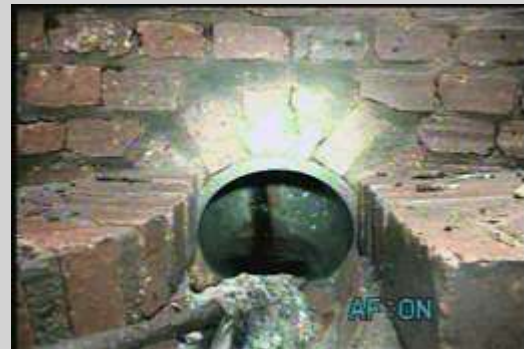
Drop In @ 3 O'Clock

Drop: **Outside Direct**

Drop Condition: **Open**

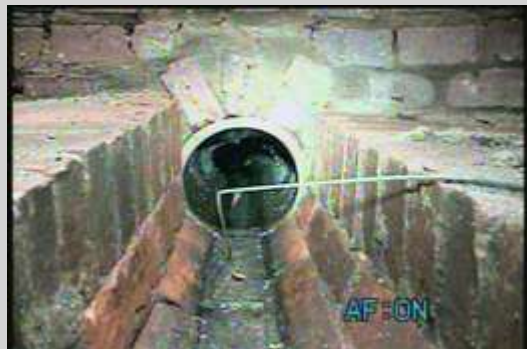
6 O'Clock Inflow

6 in. Circular Gravity Sewer
Pipe In @ 6 O'Clock

Infiltration: **None** Pipe Seal Cond: **Unknown**

Connects To: **Dead End**
